Site Overview

UBMC History

Water Treatment Plant History

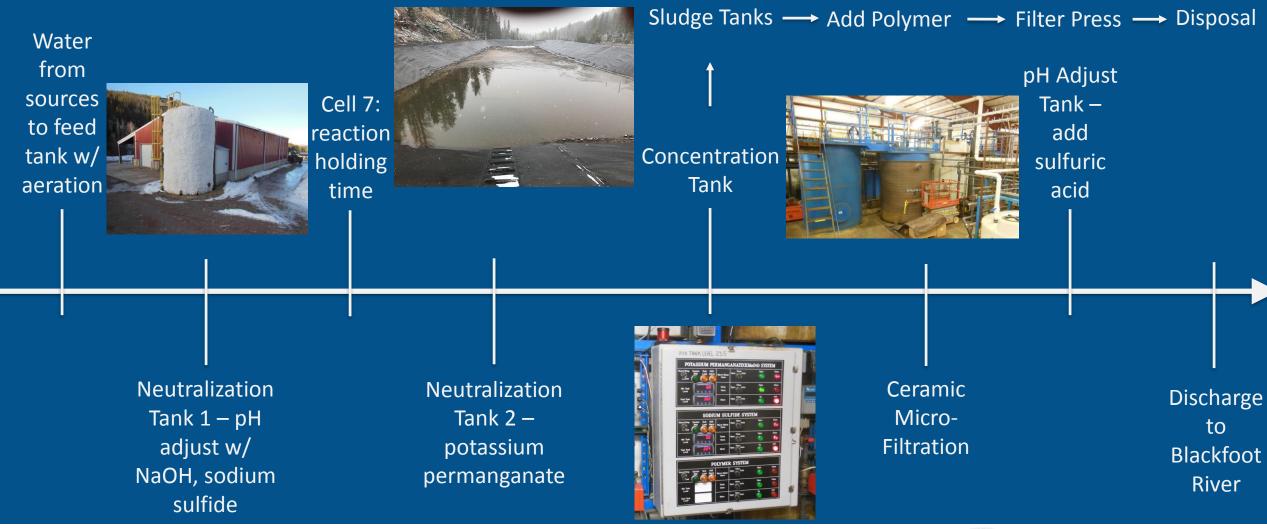
Water Treatment Process

- Built in 2008, initially put online in January 2009
- Optimized in 2011/2012 to meet final discharge limits
 - Added a second neutralization tank for the addition of potassium permanganate and sodium sulfide (primarily to address remaining Cd above standards)
- 2016 remediation work removed the lower seep capture system and eliminated clean Mike Horse Creek water from entering the mine workings
- Added Cell 7 at the WTP for additional retention time;
 reduced chemicals necessary for appropriate reaction times
 and reduced the potential for buildup in ceramic filters

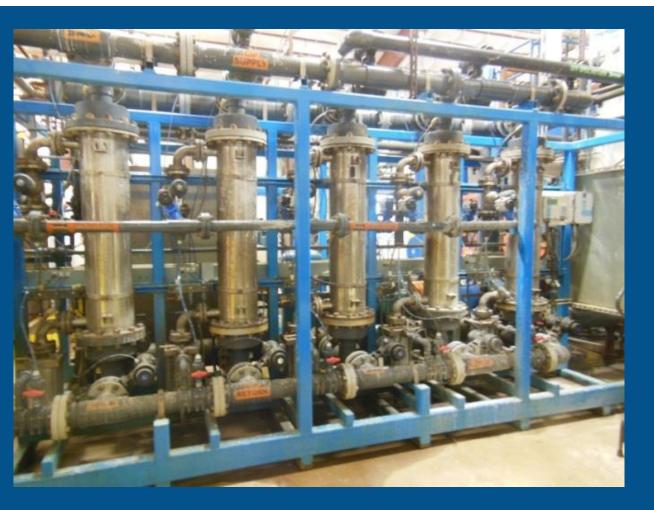
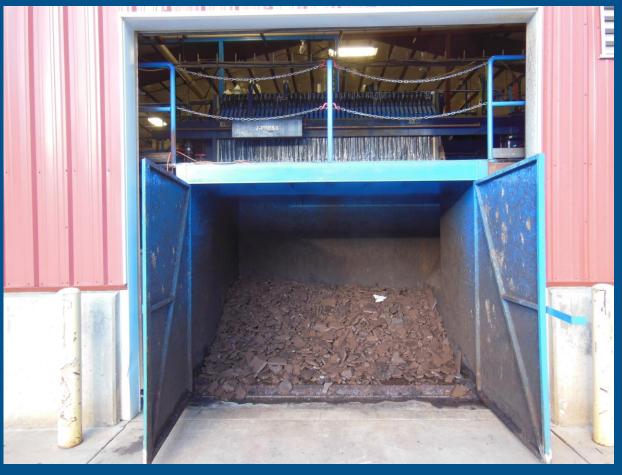
Ceramic Micro-Filtration Pumps and Filter Press w/ Finished Product
